London's Arcadia Final Evaluation 20th October 2009
Heritage Lottery Fund Application Number: HF-0200184/2

HLF Urban Area A. 5.
St. Margaret's Riverfront and Isleworth Promenade

Detailed proposals for St. Margaret's Riverfront and Isleworth Promenade

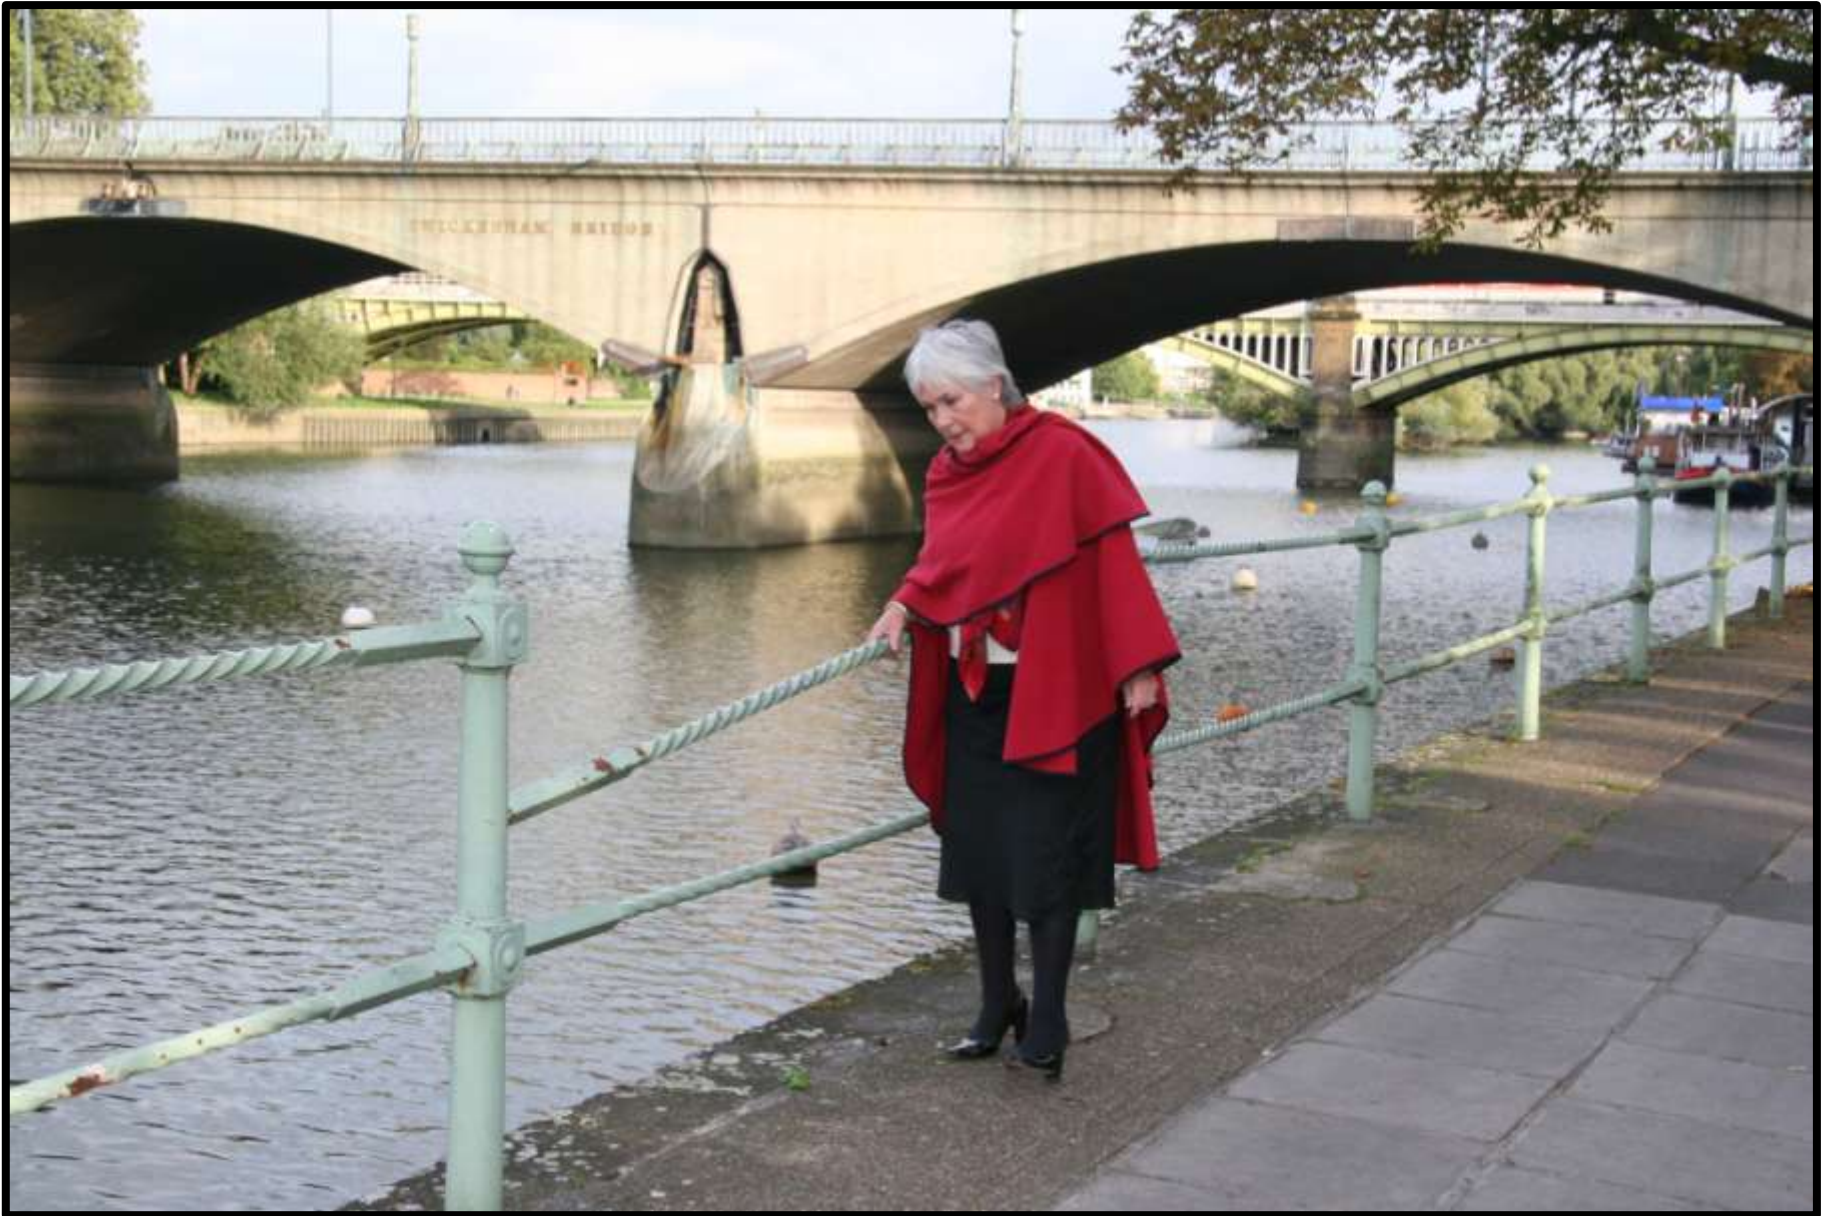
Inspecting the old broken Edwardian cast iron railings along St Margaret's Riverfront 29 Sept 05 before works started with X Cllr Annie Hambidge

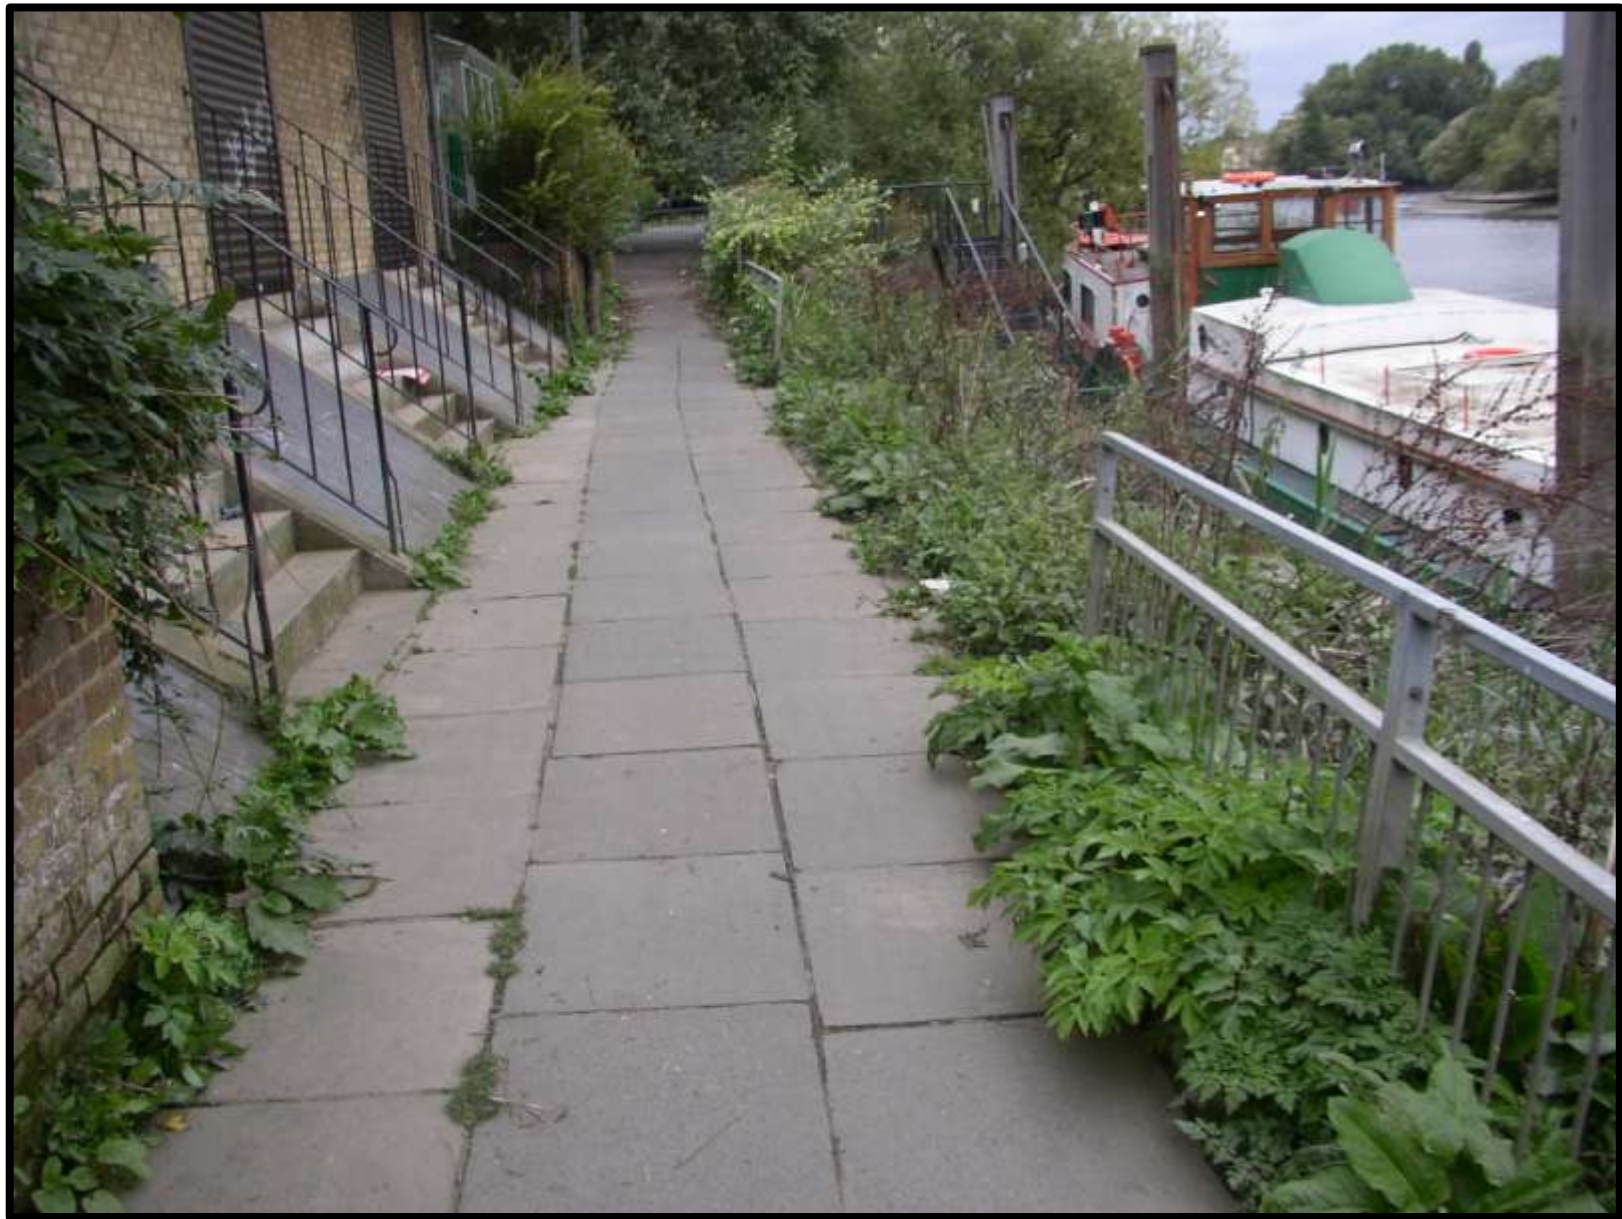
In many places the Edwardian cast iron railings along St Margaret's Riverfront had been replaced with modern galvanised railings in the 1980's but even these had failed in locations as seen here on 17 Sept 2004 as one approaches Isleworth Promenade.

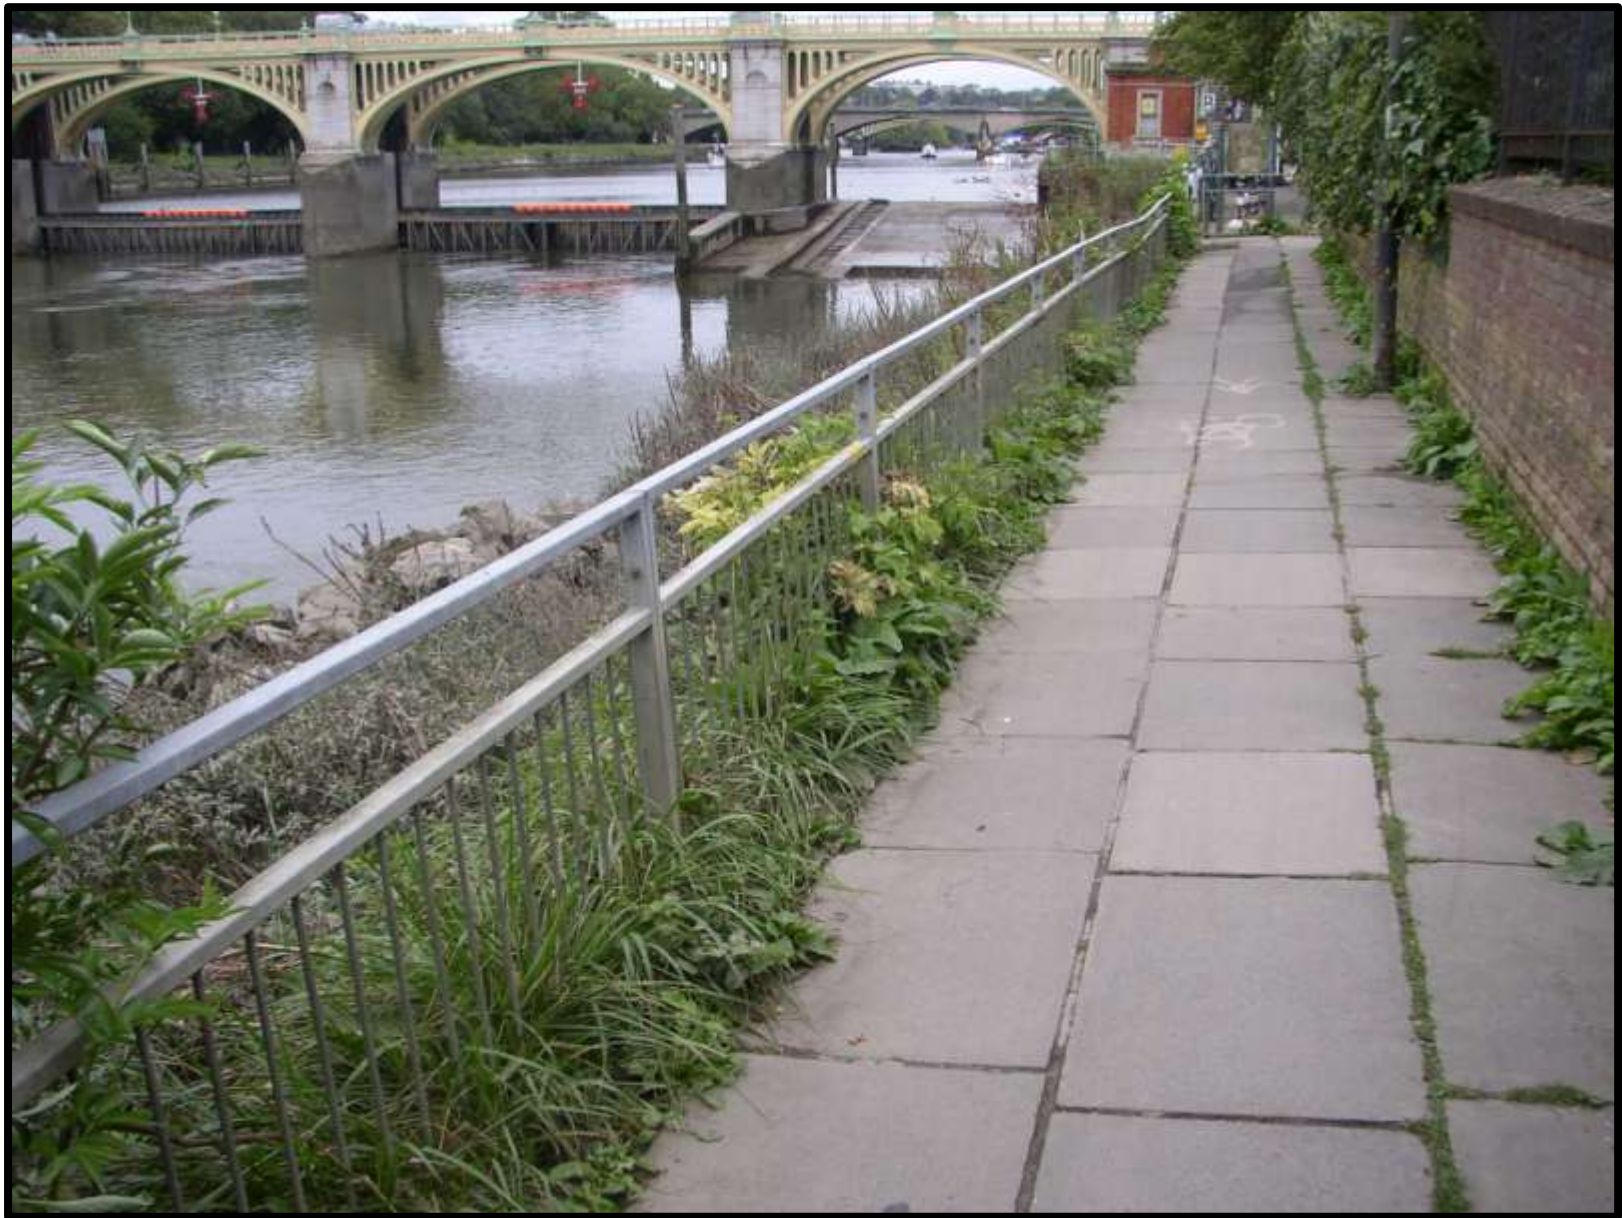
In many places the Edwardian cast iron railings along St Margaret's Riverfront had been replaced with modern galvanised railings in the 1980's as seen here on 17 Sept 2004 as one looks towards the grade II* Richmond Lock.

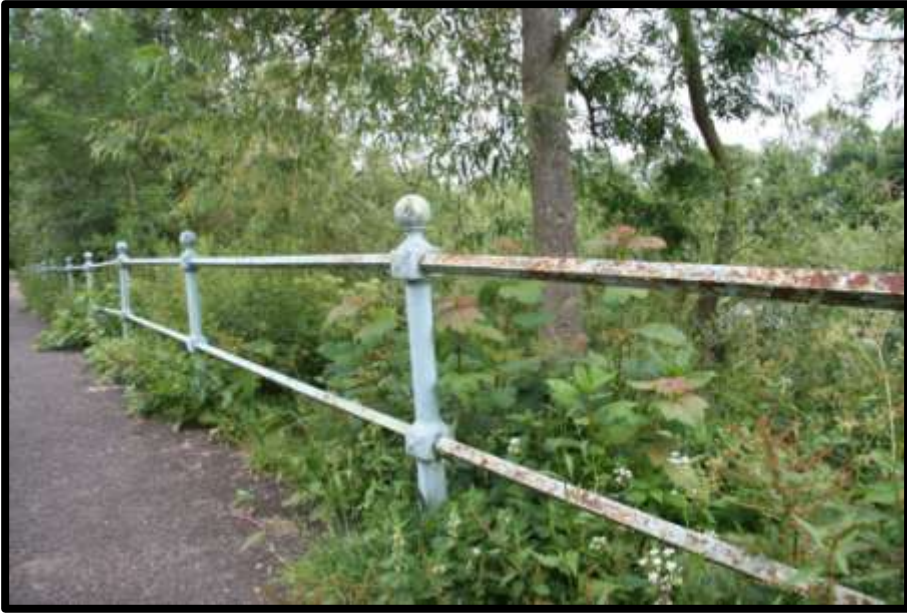
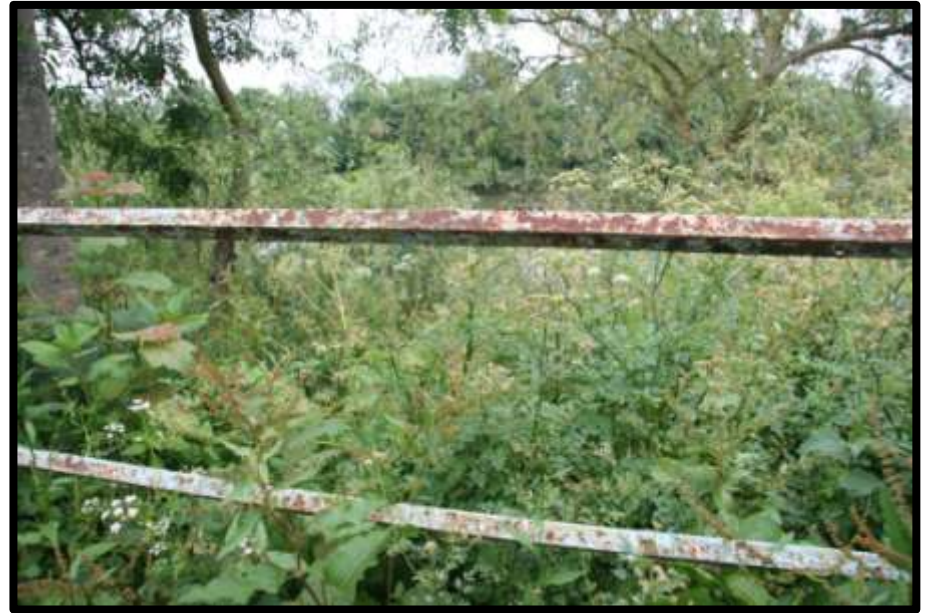
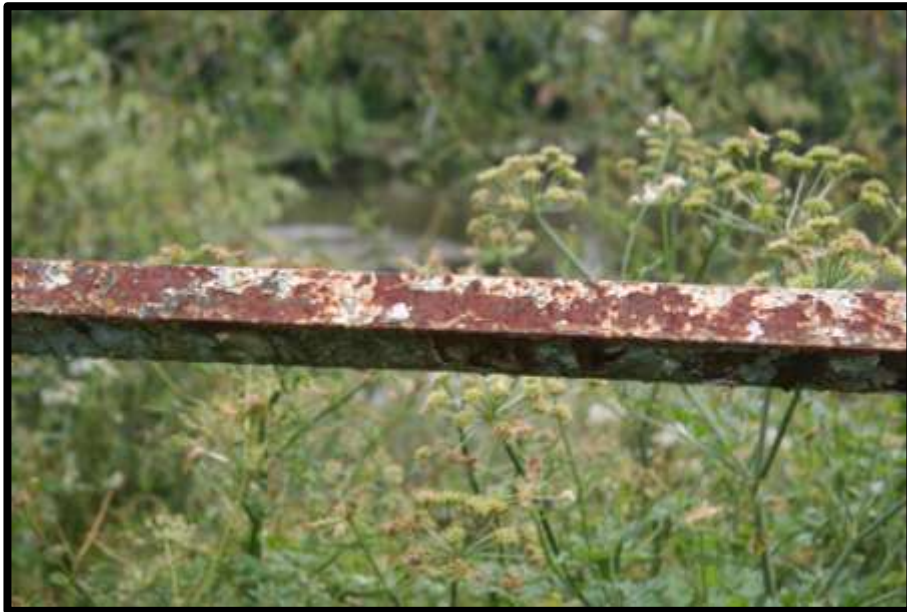
Detail inspections of the old broken Edwardian cast iron railings along St Margaret's Riverfront and Isleworth Promenade 29 August 2005 before works started . Nearly a mile of cast iron railings were restored as part of the works. Note that one cannot even see the River Thames in these photos due to the mass of shrub along the revetments.

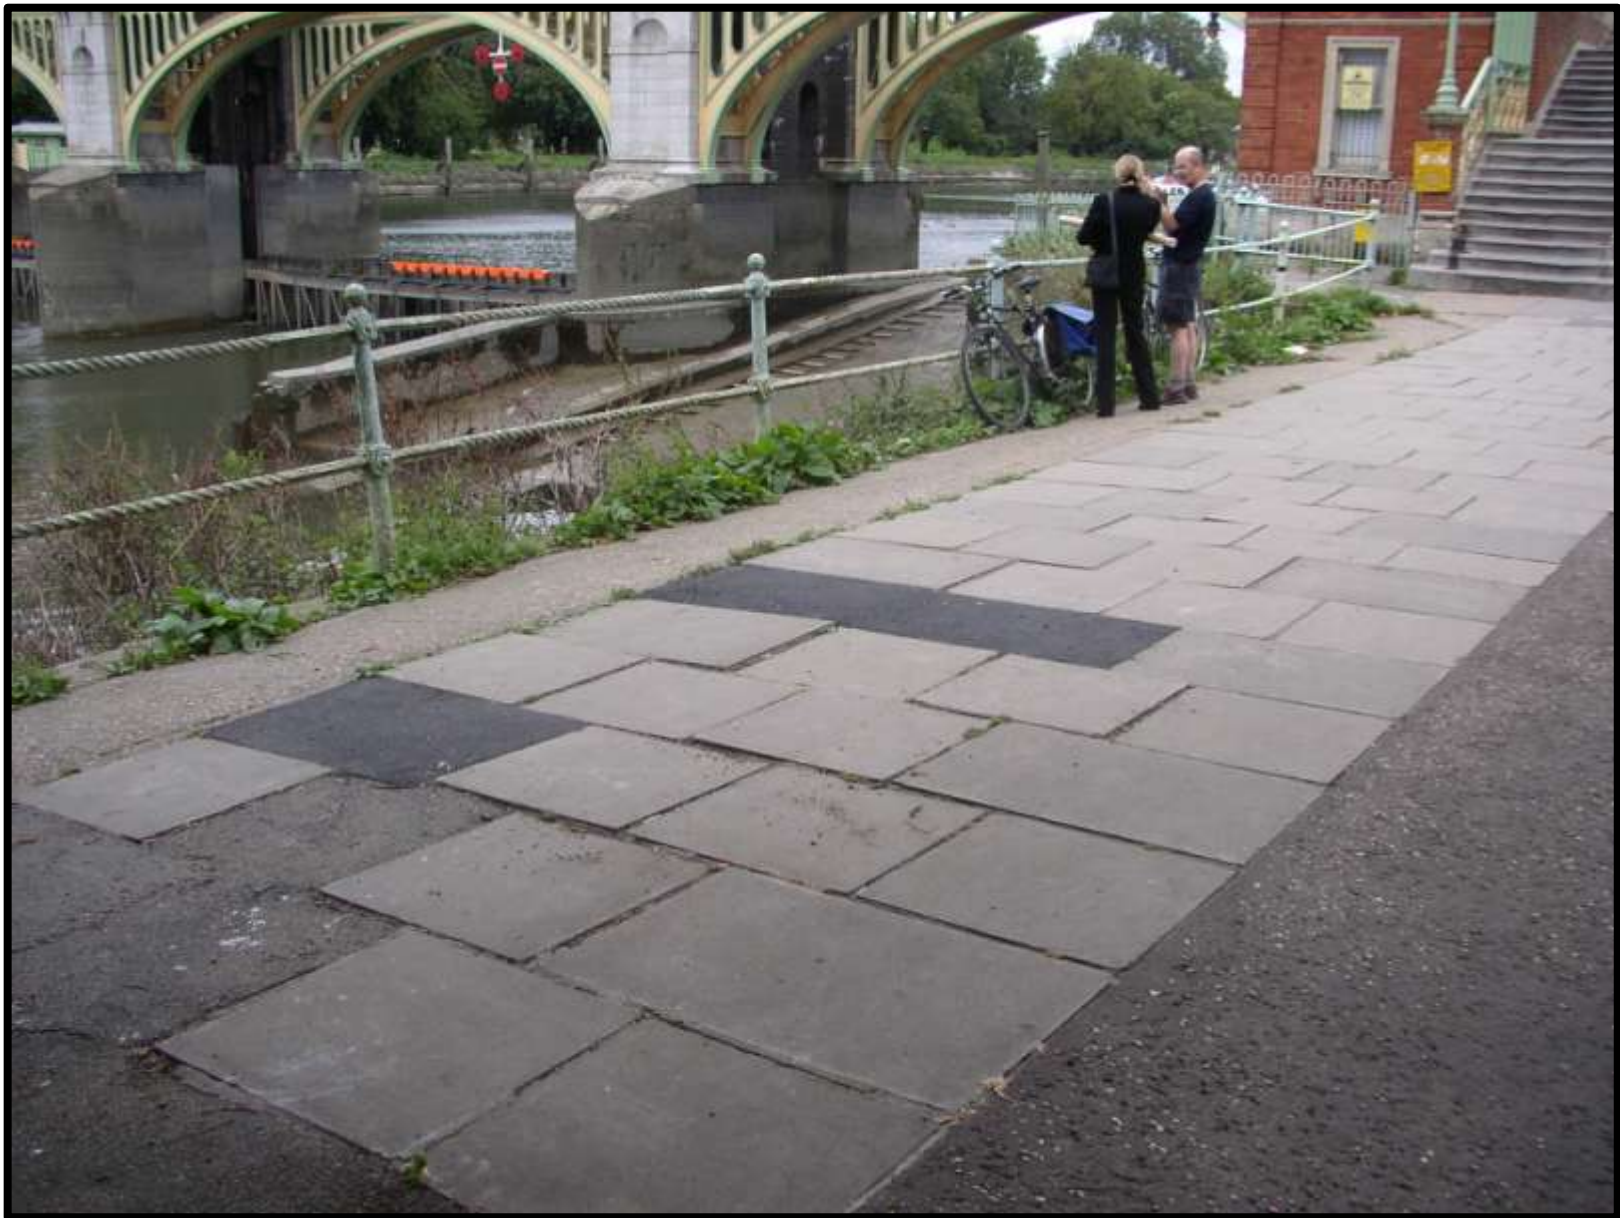
Inspecting the old broken Edwardian cast iron railings along St Margaret's Riverfront 17 Sept 2004 before works started by grade II* Richmond Lock

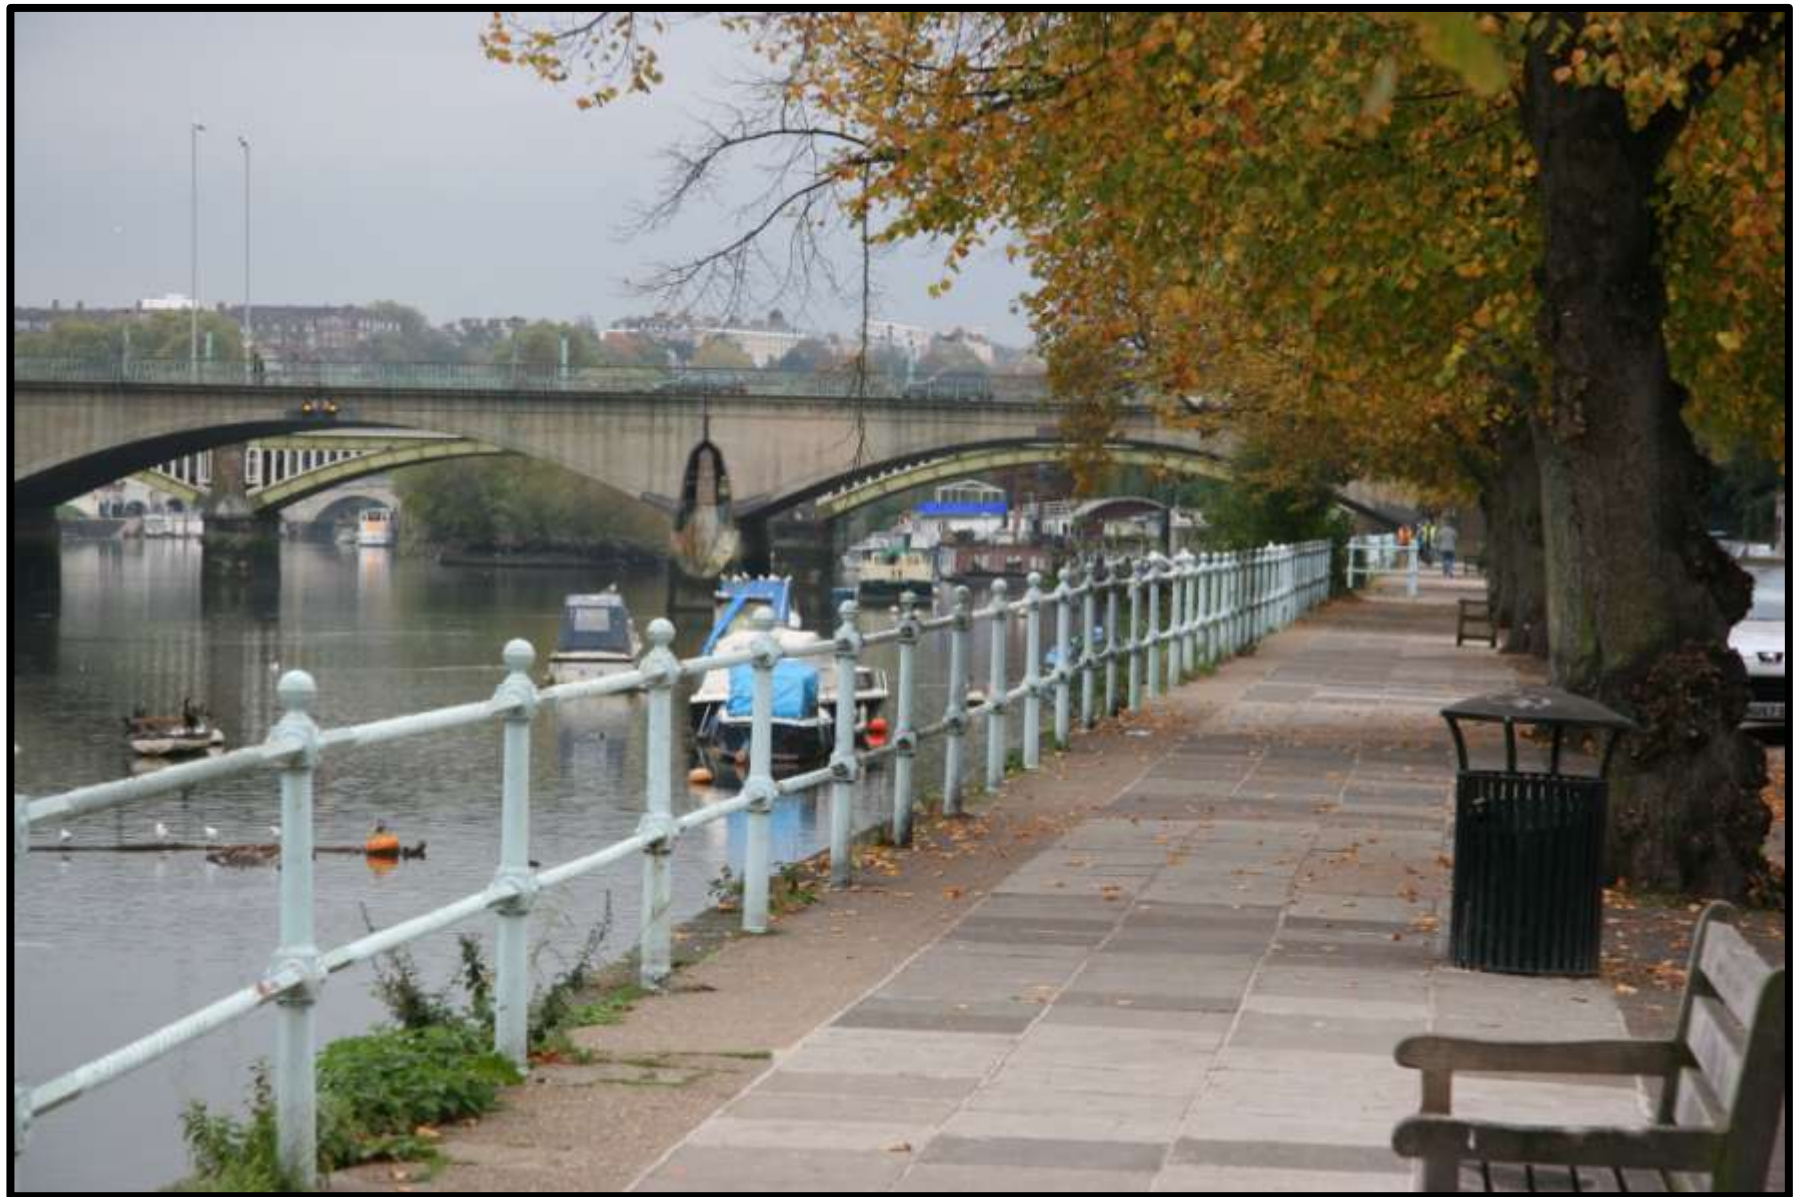
The restored Edwardian cast iron railings along St Margaret's Riverfront and Isleworth Promenade after works completed with new street furniture and interpretation. Nearly a mile of cast iron railings were restored as part of the works.

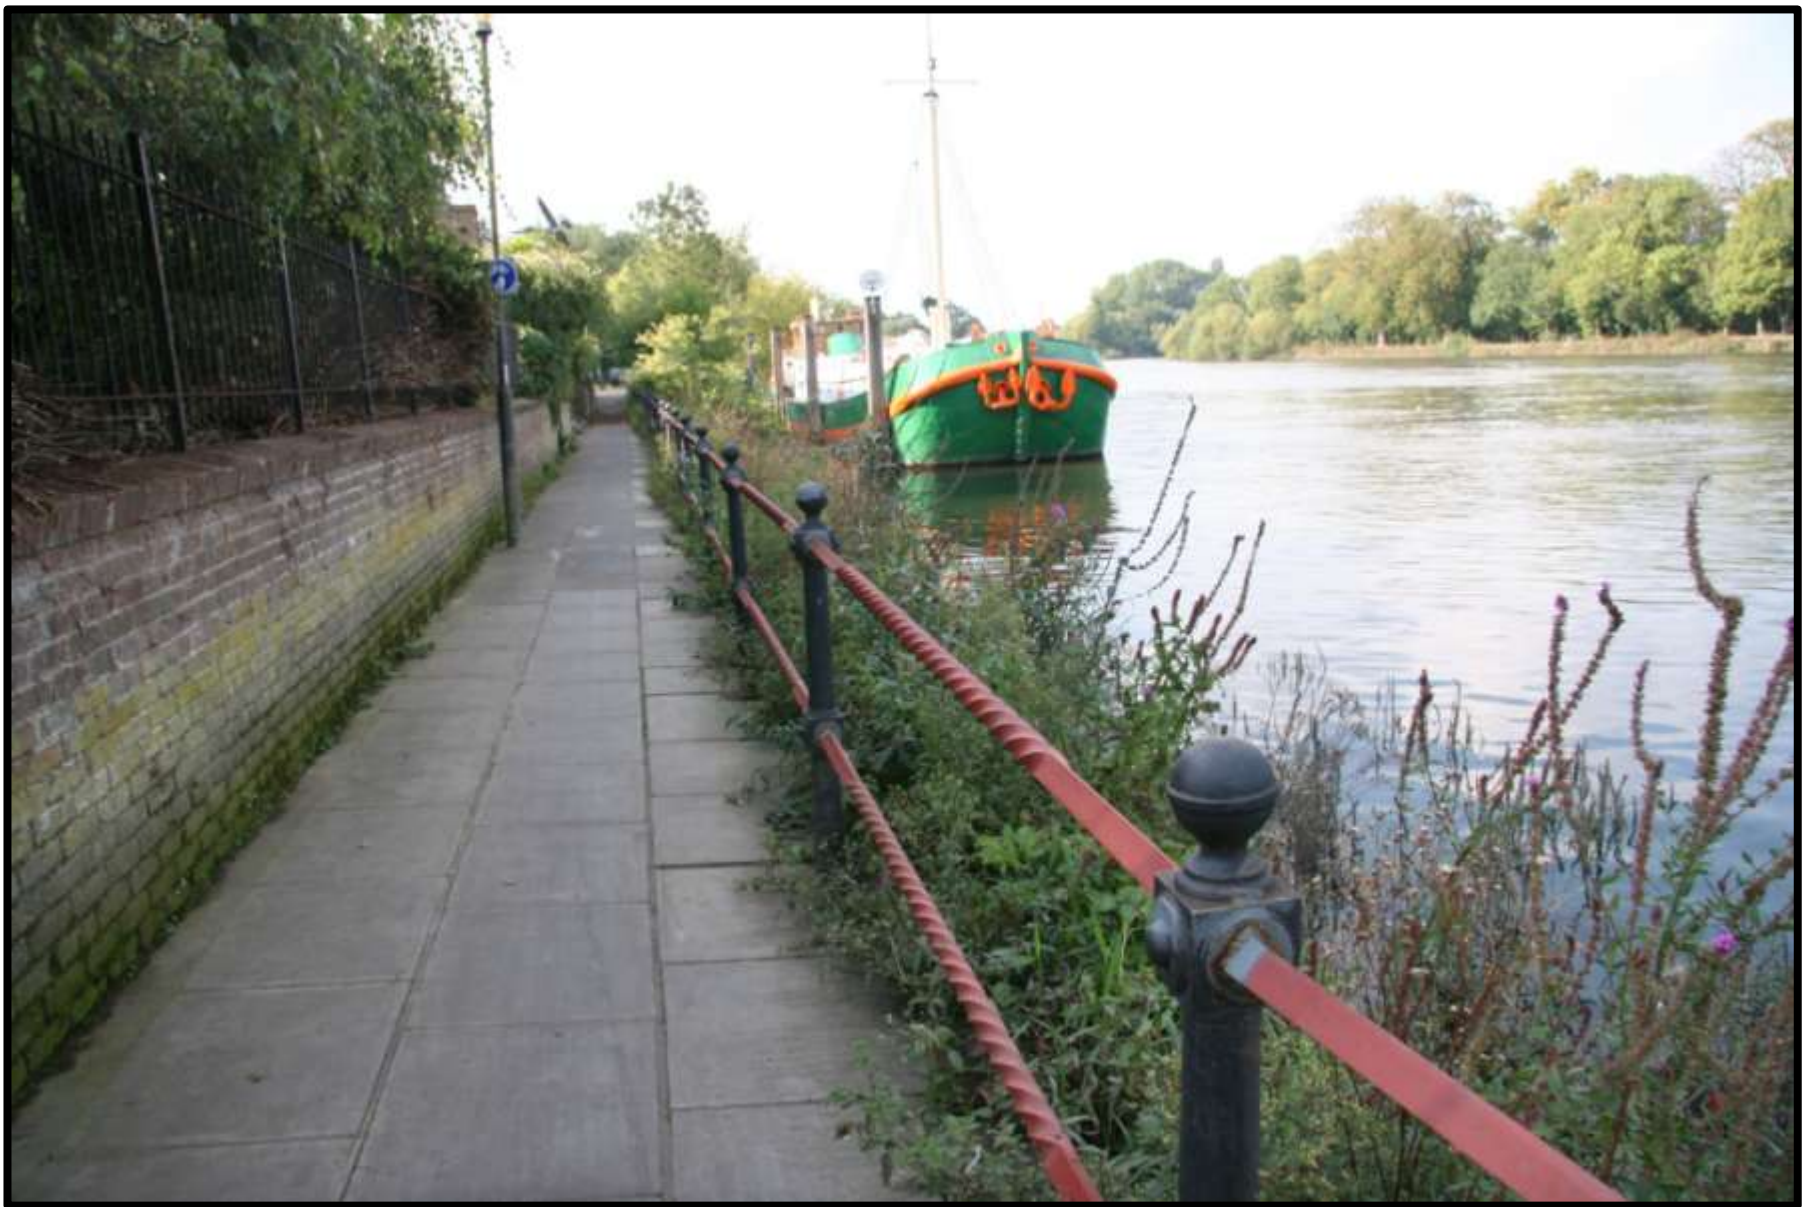
Works underway to restore the Edwardian cast iron railings along St Margaret's Riverfront and Isleworth Promenade 14 September 2007. Nearly a mile of cast iron railings were restored as part of the works.

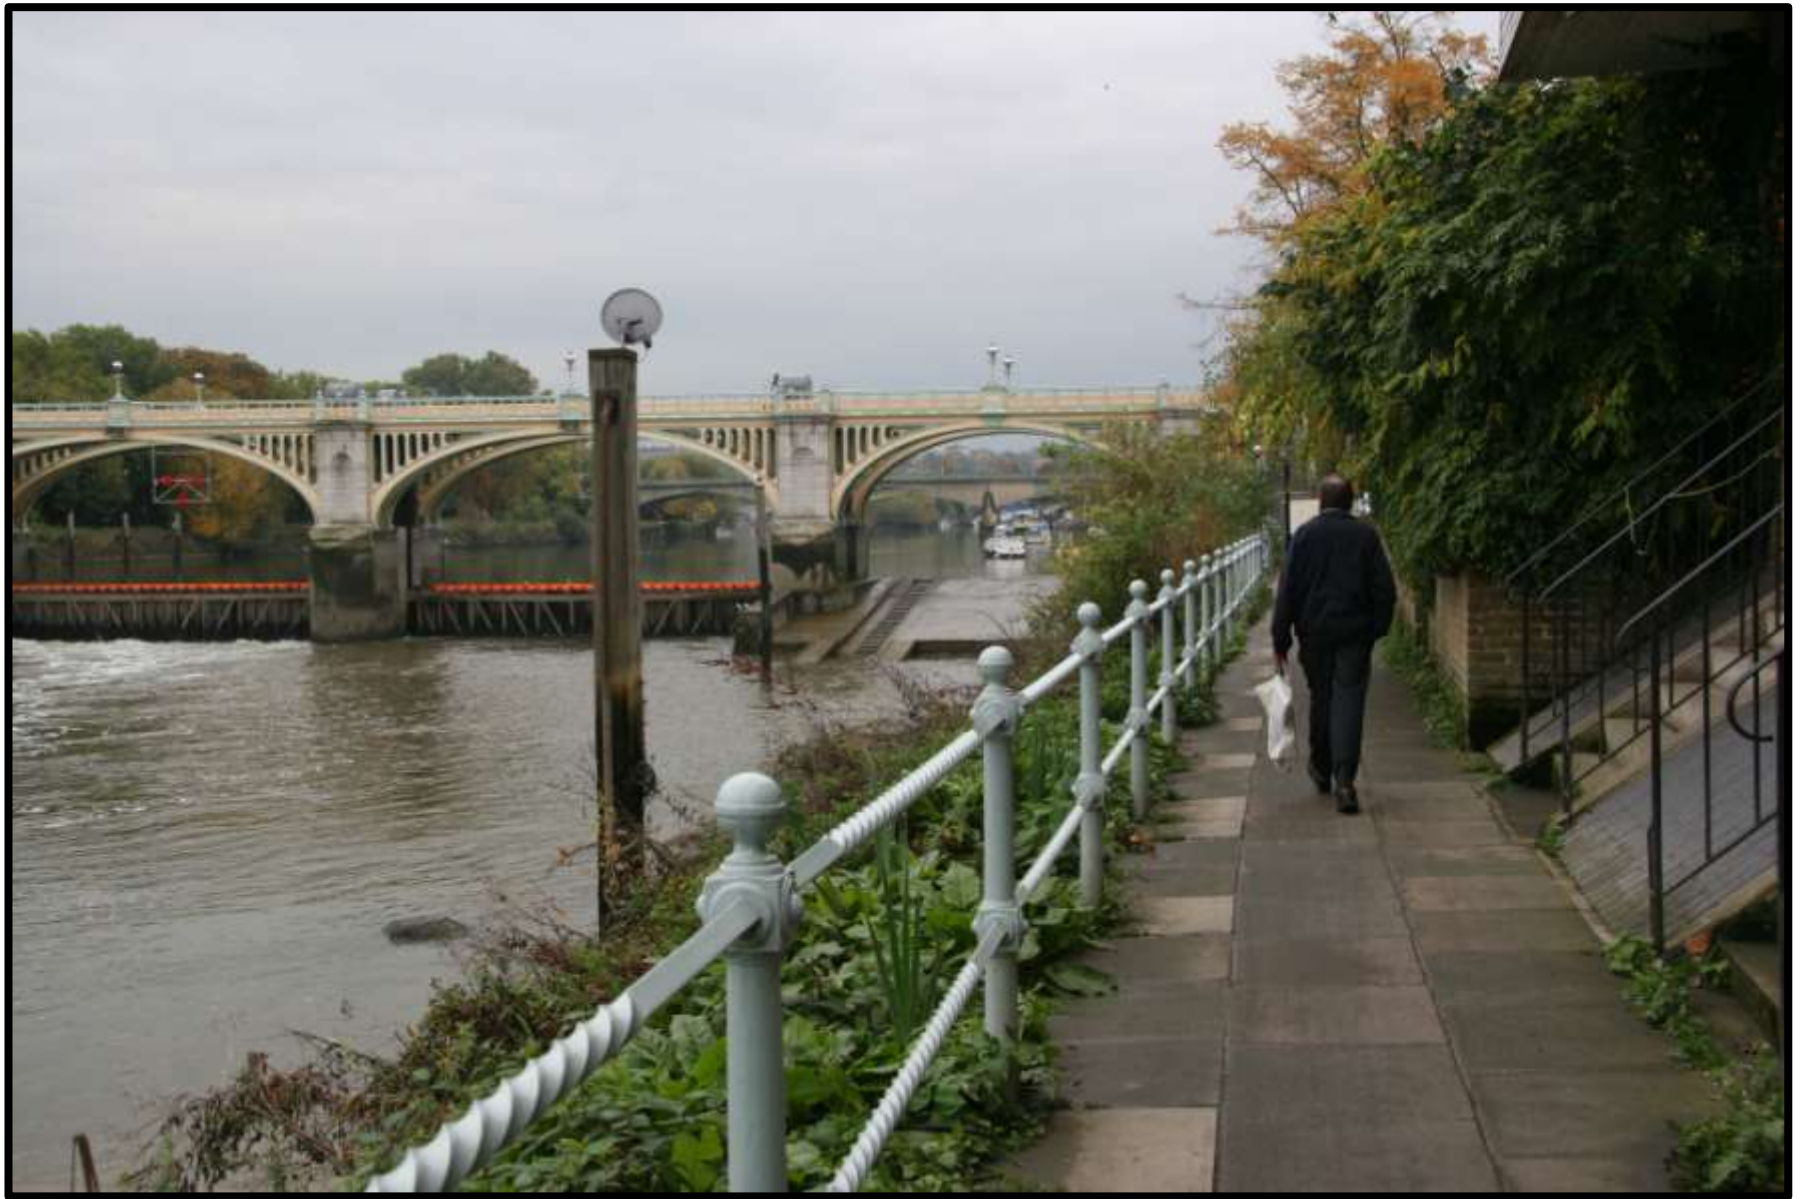
The restored Edwardian cast iron railings along St Margaret's Riverfront and Isleworth Promenade 1 October 2007 looking towards the grade II* Richmond Lock. Nearly a mile of cast iron railings were restored as part of the works.

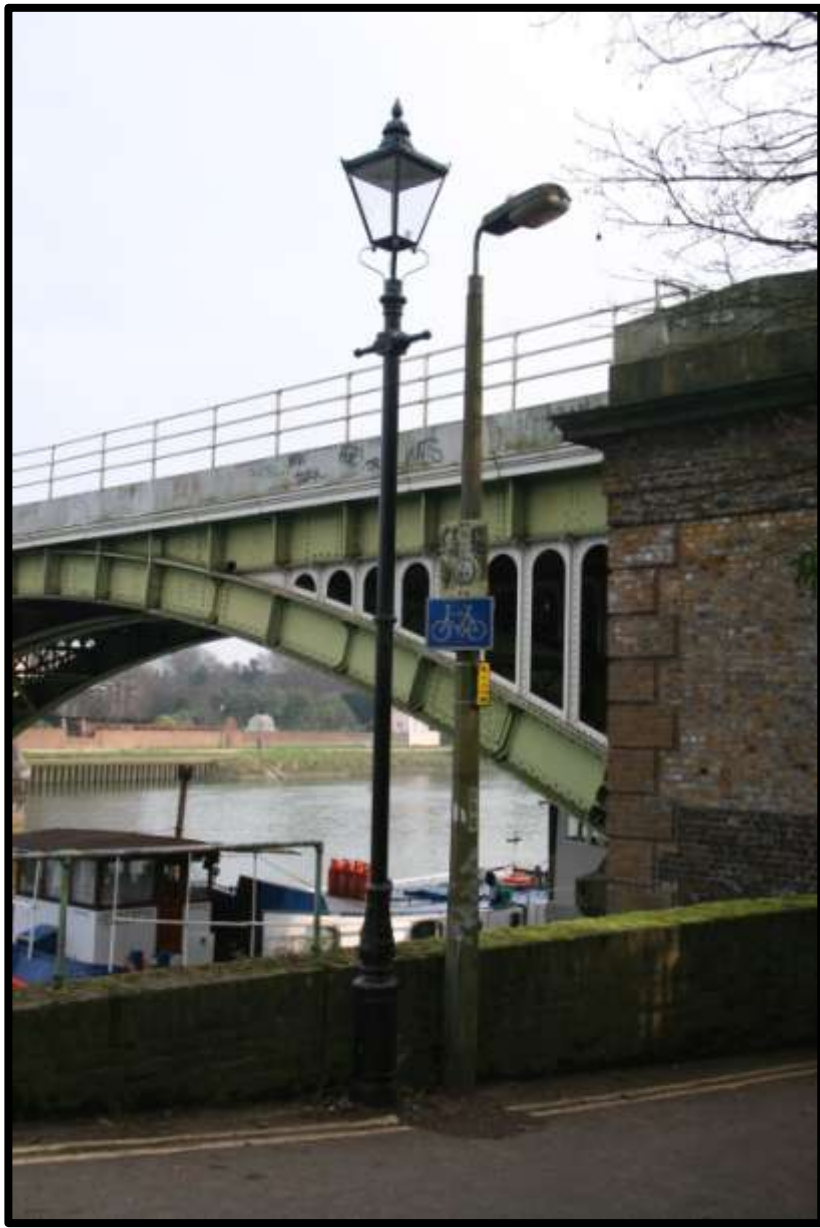
New street lighting was fitted at the entrance point to St Margaret's Riverfront between Richmond Railway Bridge and Twickenham Bridge (grade II), replacing the old 1970 utilitarian concrete lamps.

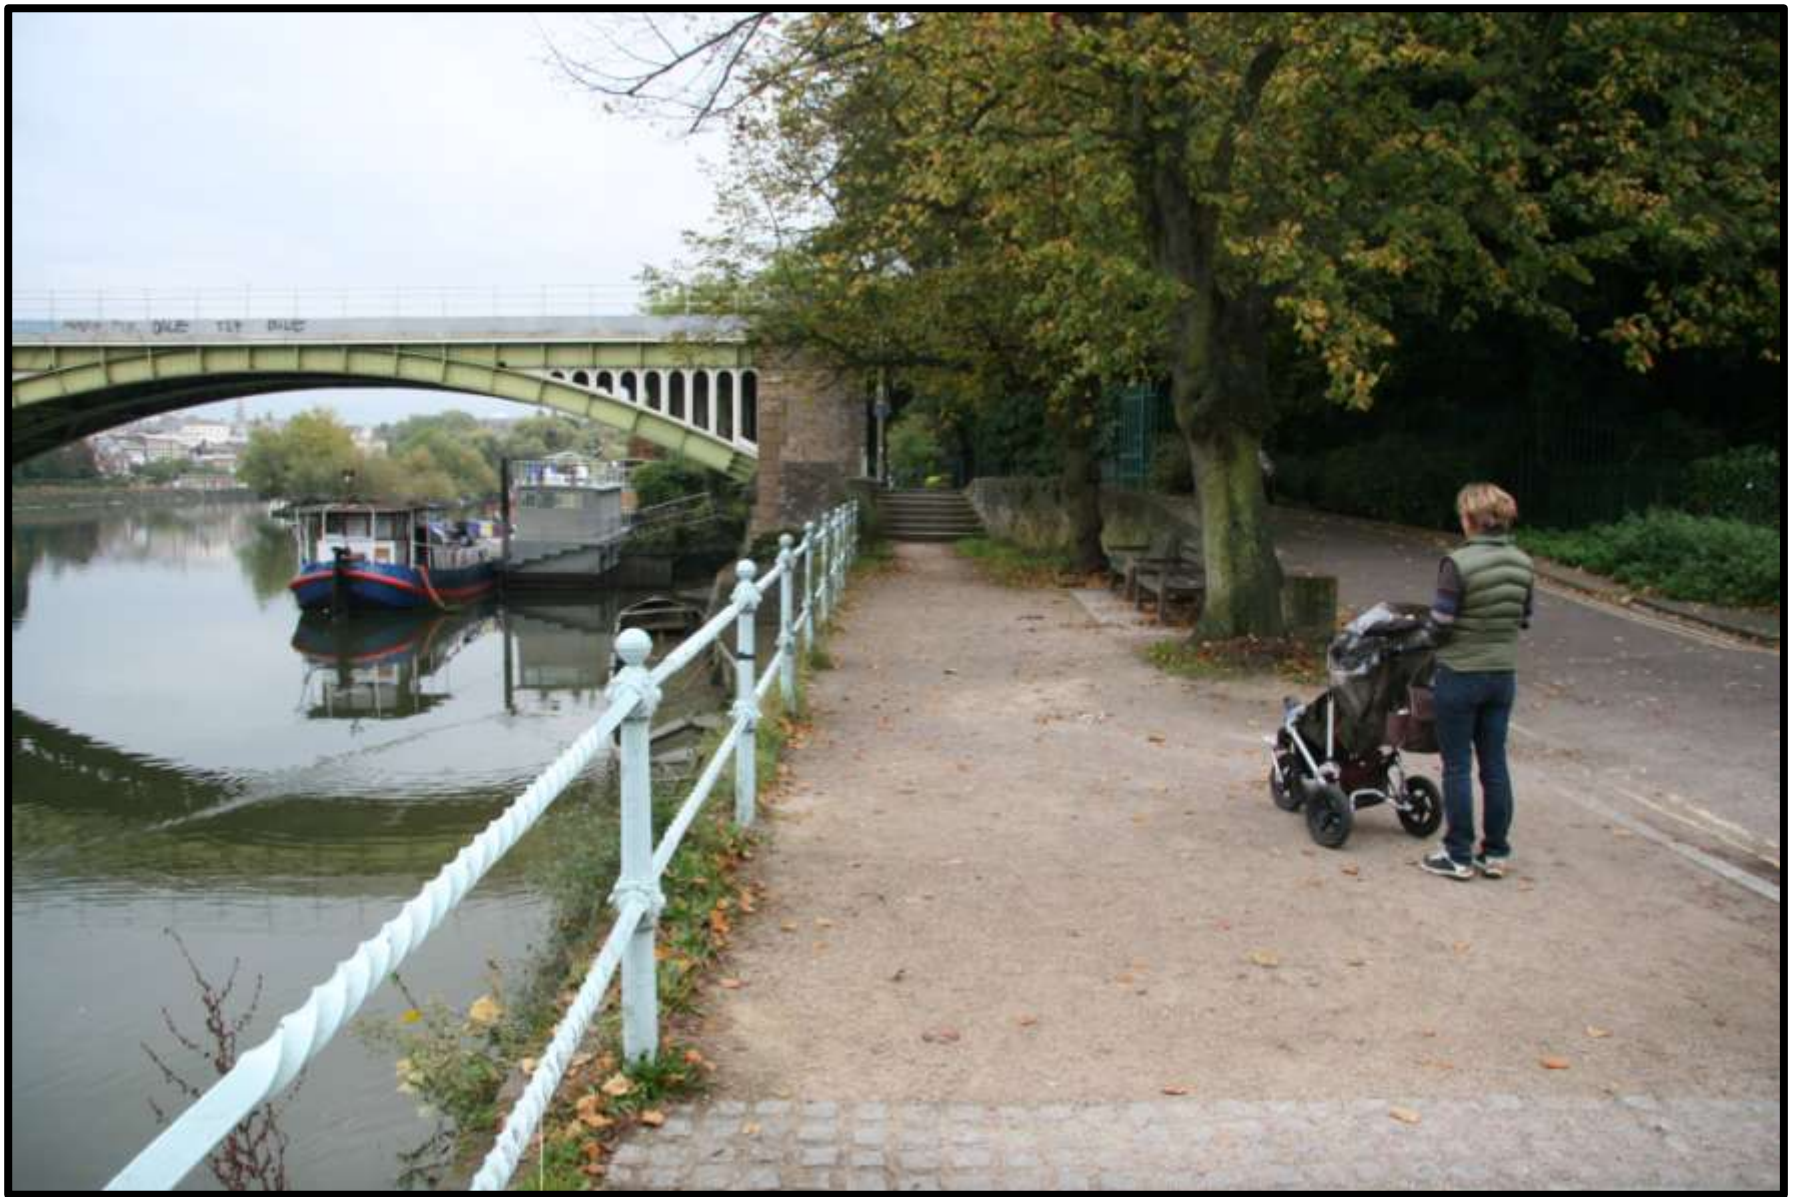
The restored Edwardian cast iron railings along St Margaret's Riverfront and Isleworth Promenade 12 October 2009 looking across the small pocket park created between Richmond Railway Bridge and Twickenham Bridge (grade II) looking up towards Richmond Hill in the background

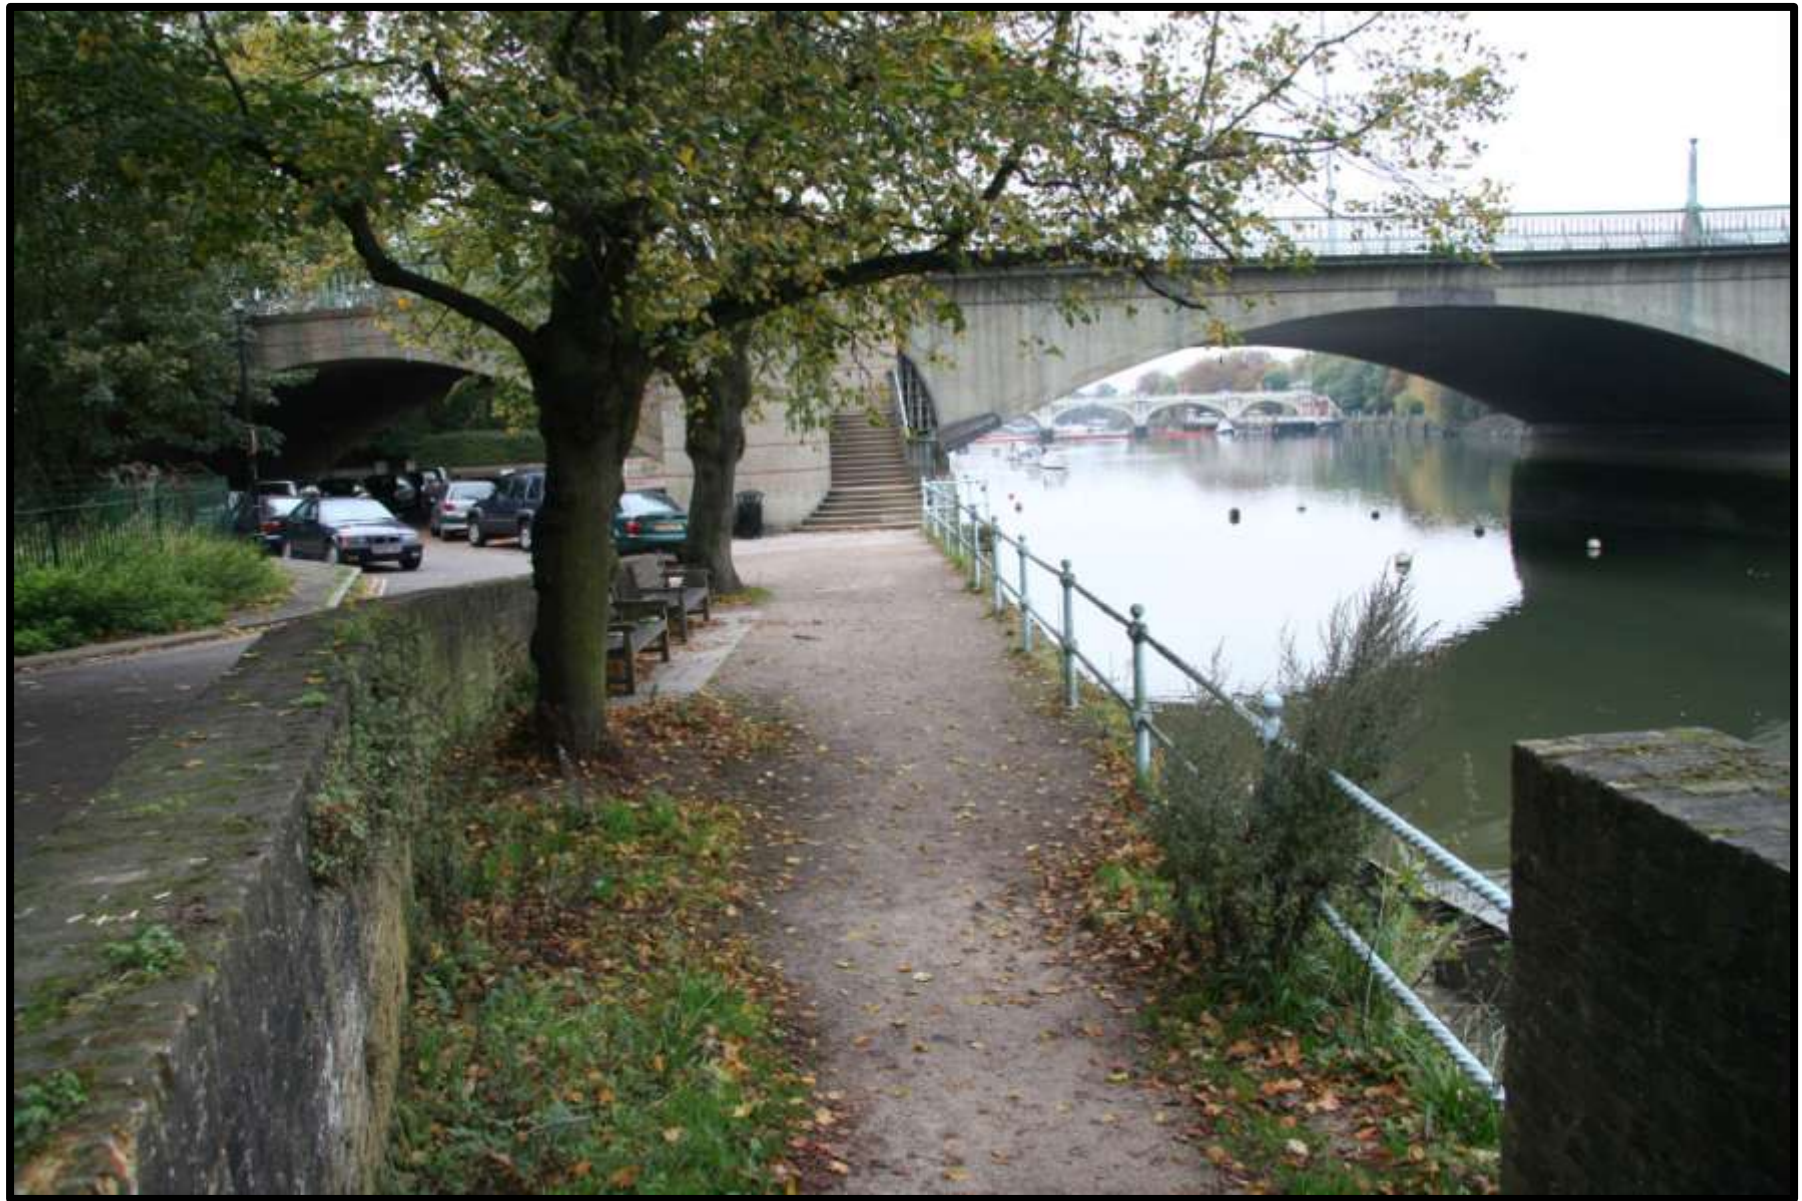
The restored Edwardian cast iron railings along St Margaret's Riverfront and Isleworth Promenade 12 Sept 2009 looking across the small pocket park created between Richmond Railway Bridge and Twickenham Bridge (grade II) looking downriver under Twickenham Bridge to the grade II* Richmond Lock.
