London's Arcadia Final Evaluation 20th October 2009
Heritage Lottery Fund Application Number: HF-0200184/2

HLF Urban Area A. 5.
St. Margaret's Riverfront and Isleworth Promenade

Detailed proposals for St. Margaret's Riverfront and Isleworth Promenade

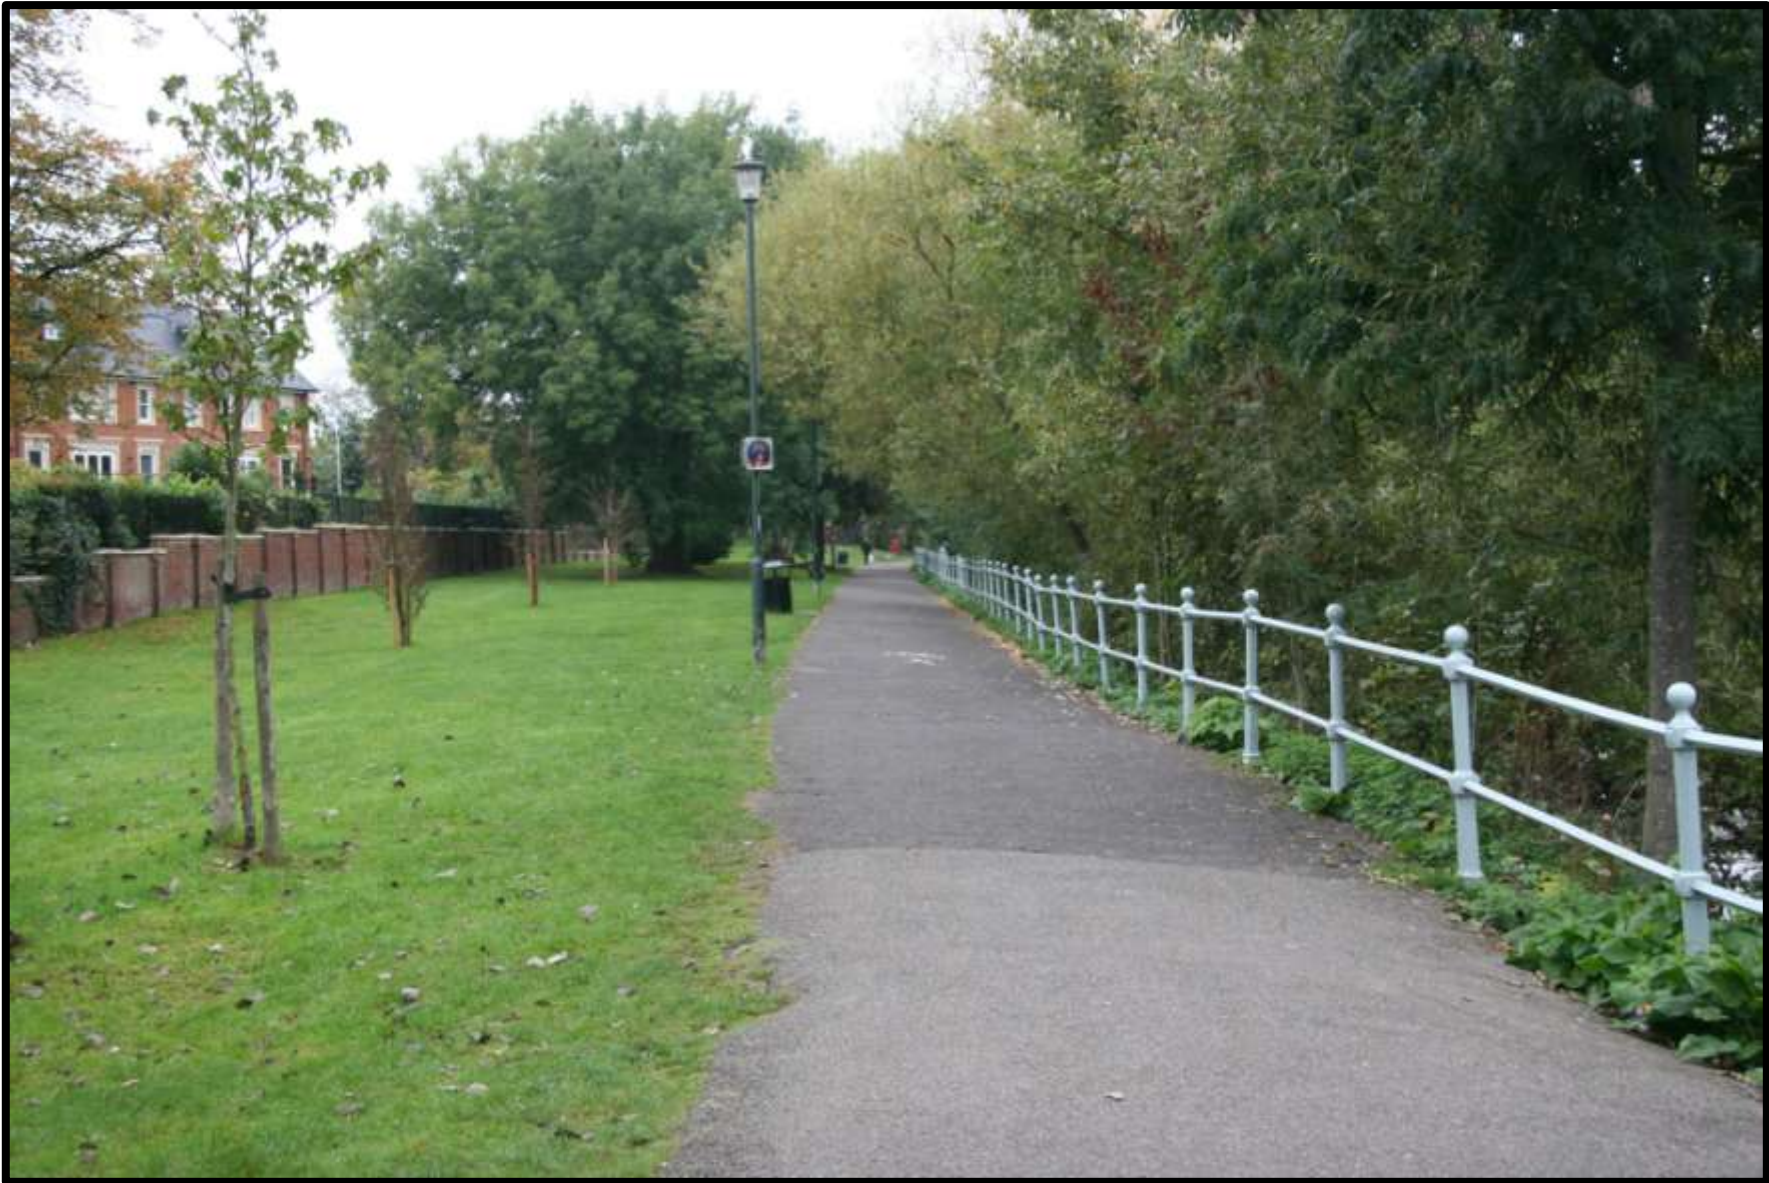
The restored Edwardian cast iron railings along Isleworth Promenade after works completed with new street furniture in background and new landscaped areas with trees planted. Nearly a mile of cast iron railings were restored as part of the works.

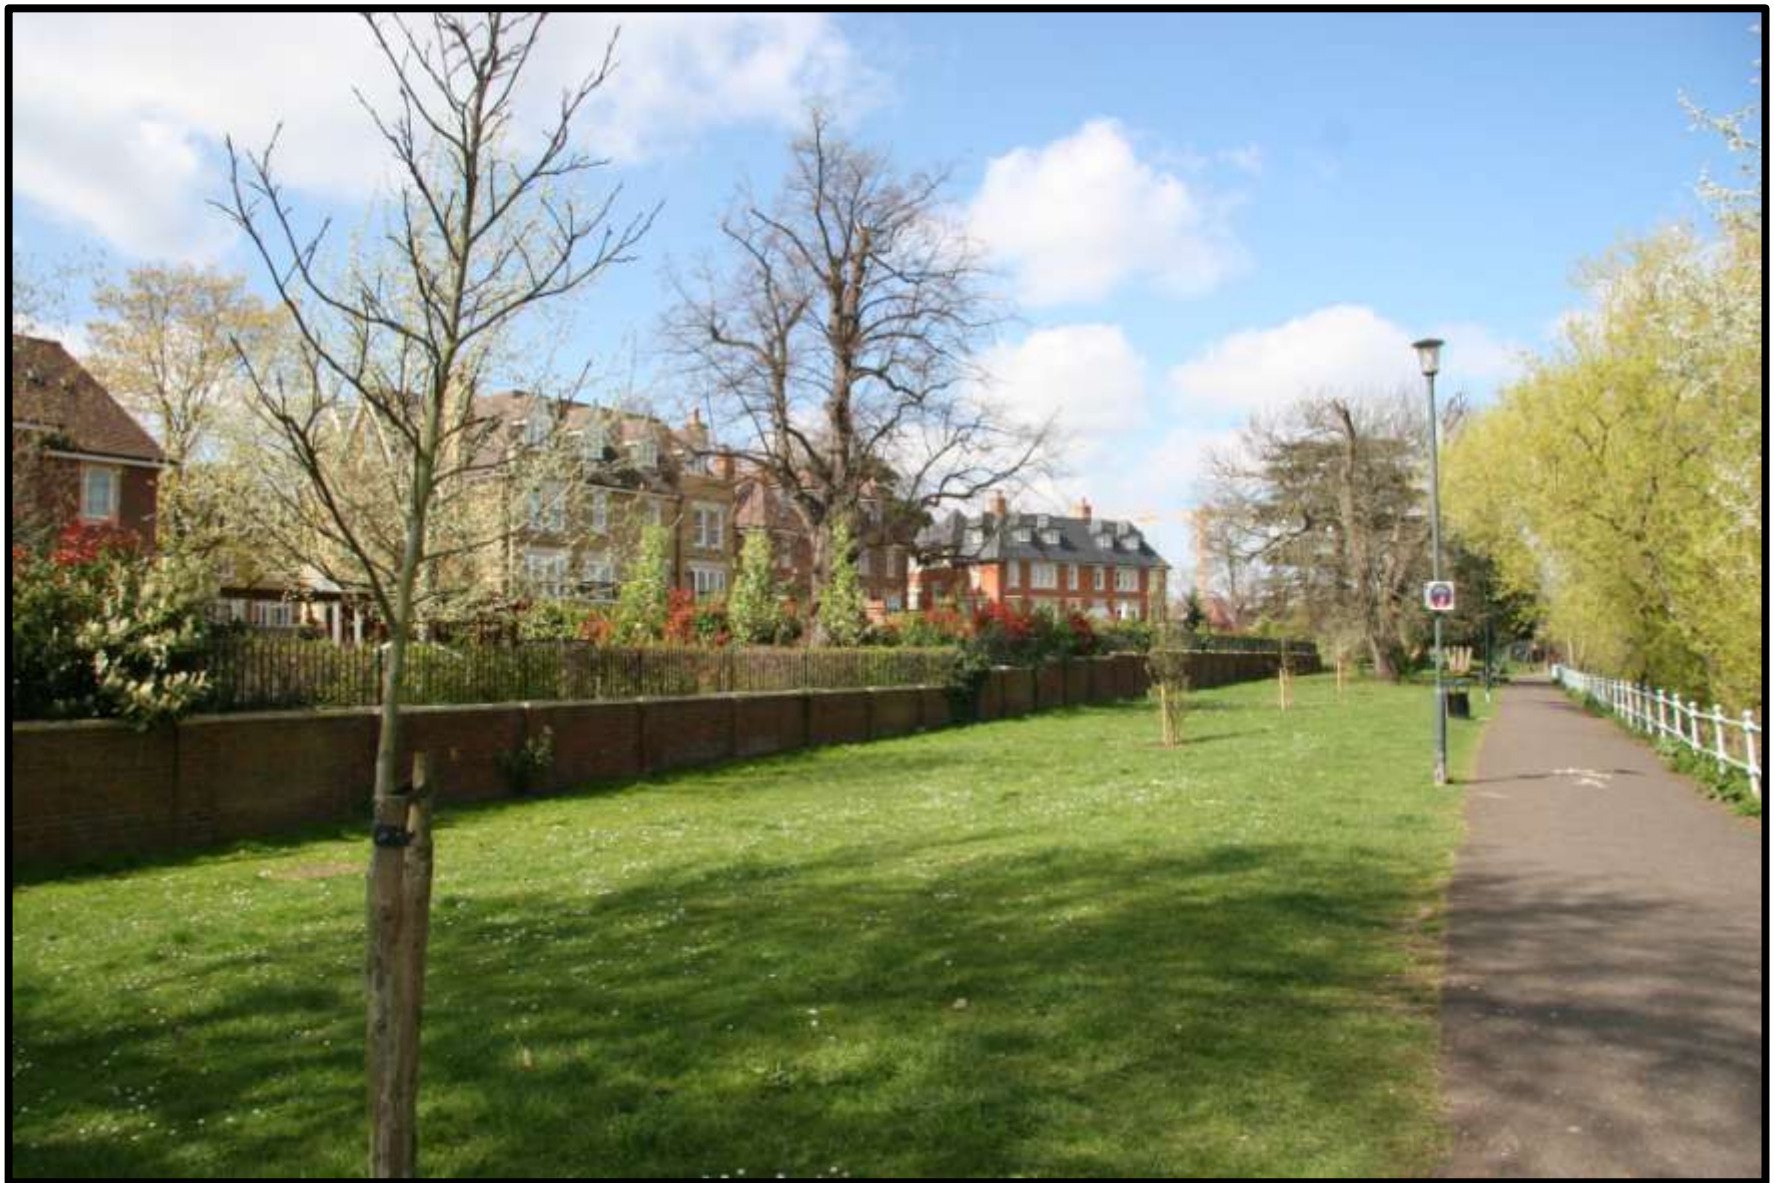
The restored Edwardian cast iron railings along Isleworth Promenade after works completed with new street furniture in background and new landscaped areas with trees planted 9 April 2009. Nearly a mile of cast iron railings were restored as part of the works.

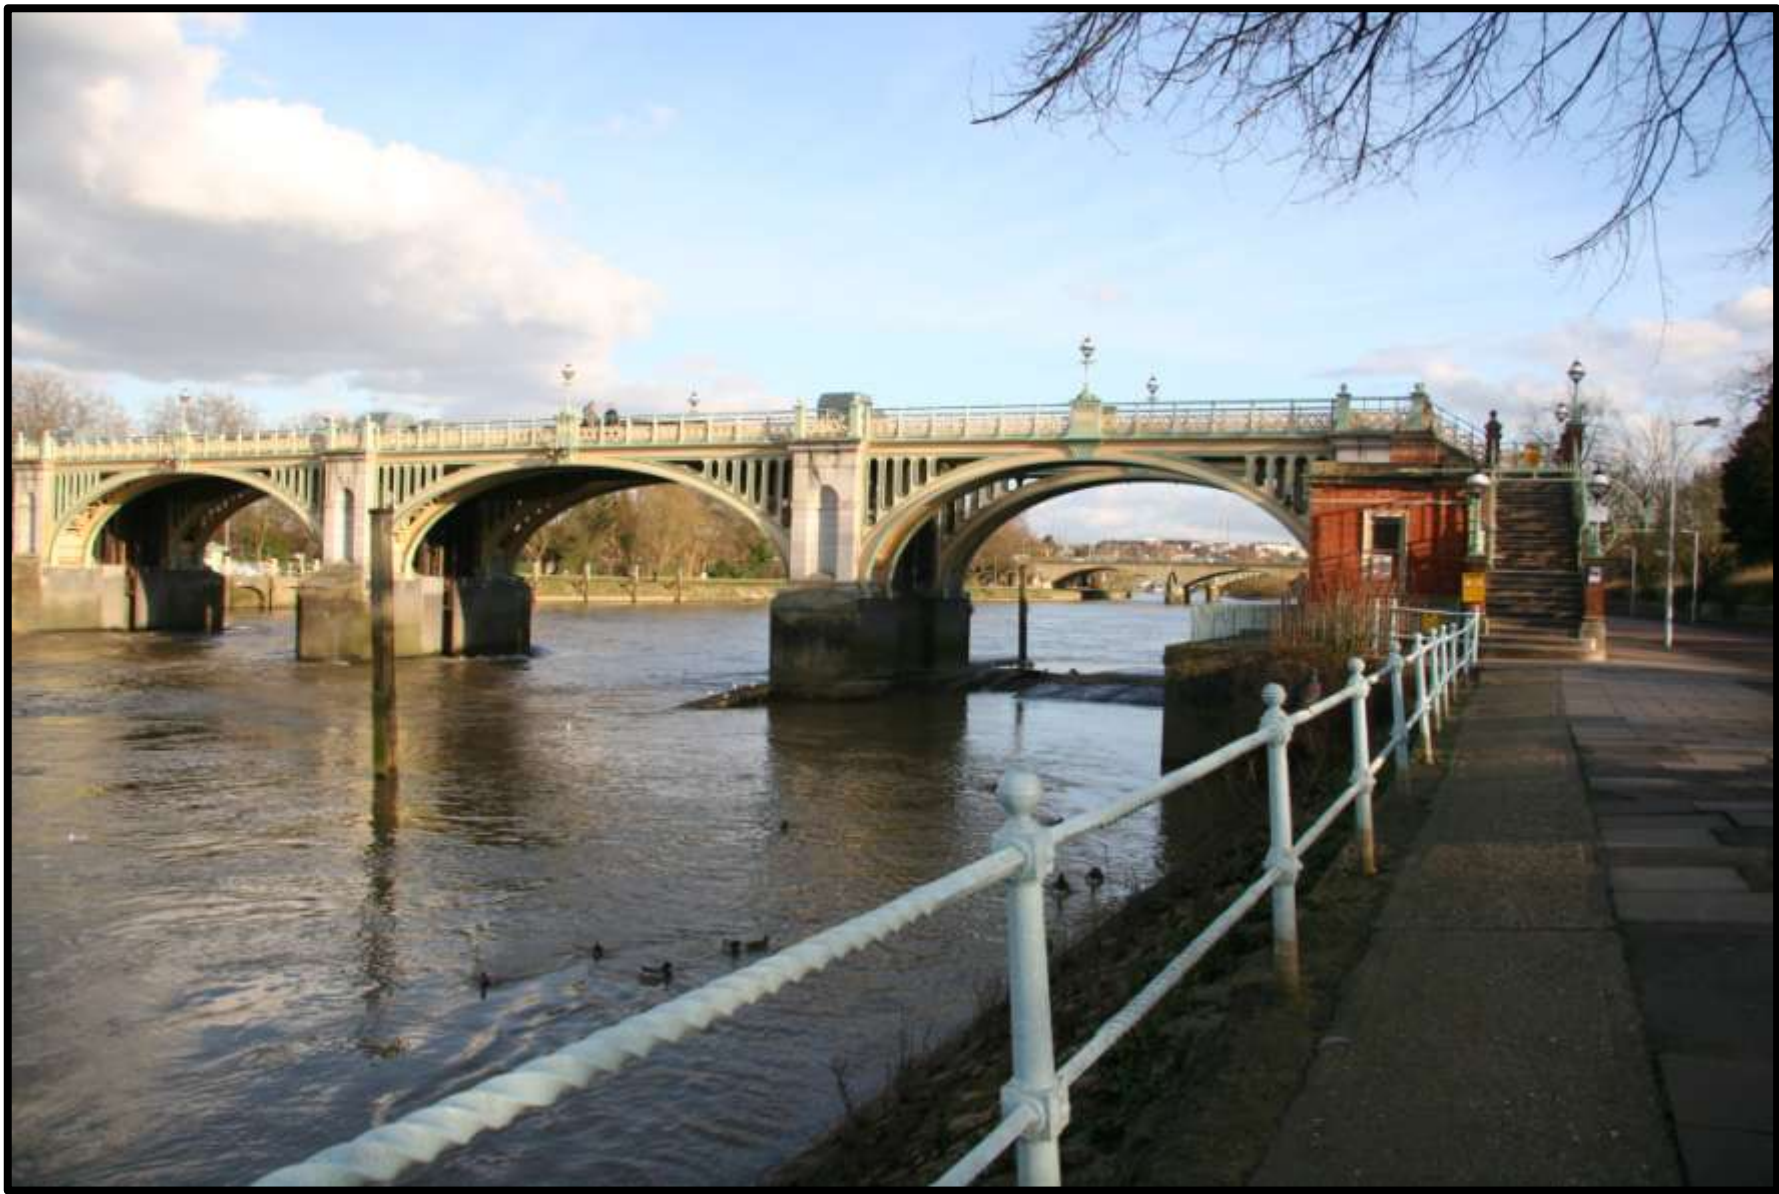
The restored Edwardian cast iron railings along St Margaret's Riverfront and Isleworth Promenade 26 February 2007 looking to the grade II* Richmond Lock.

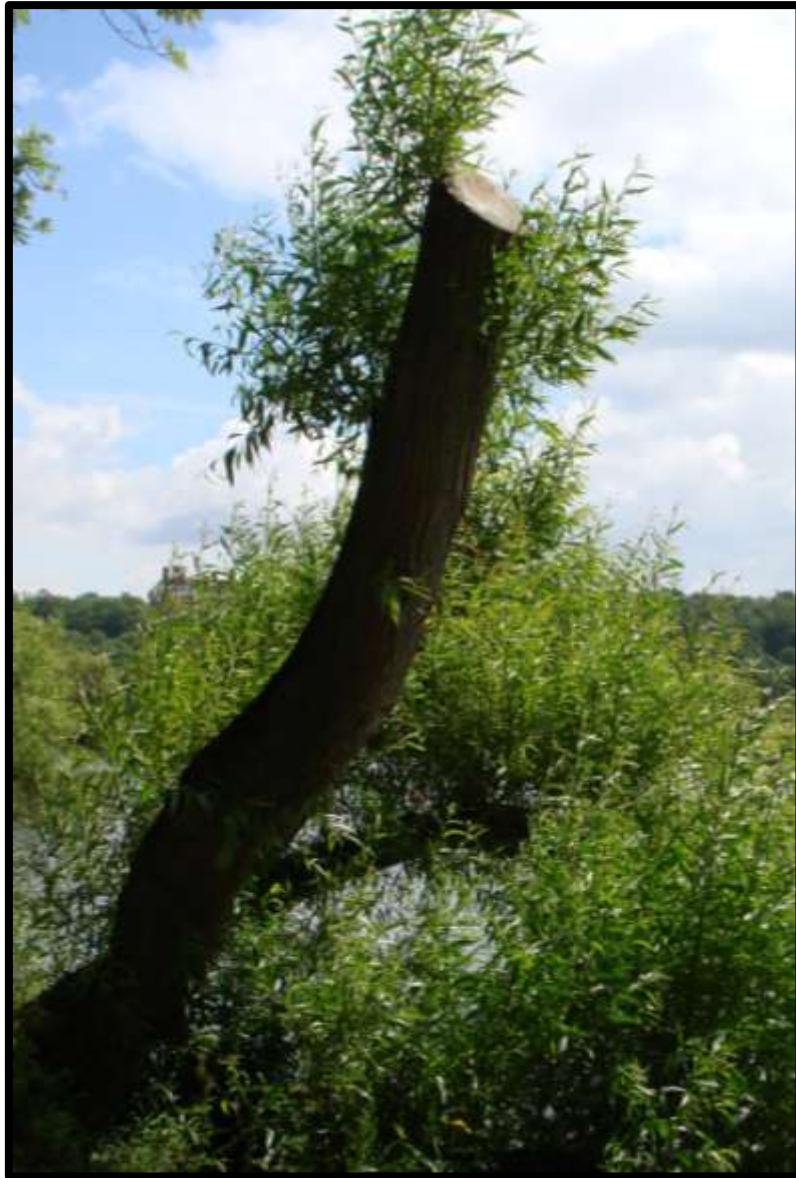
Photo showing extensive tree pollarding to preserve the mature willows and open up strategic views to the River Thames and the Old Deer Park, spring 2005 as willows sprouts new shoots from latent buds.

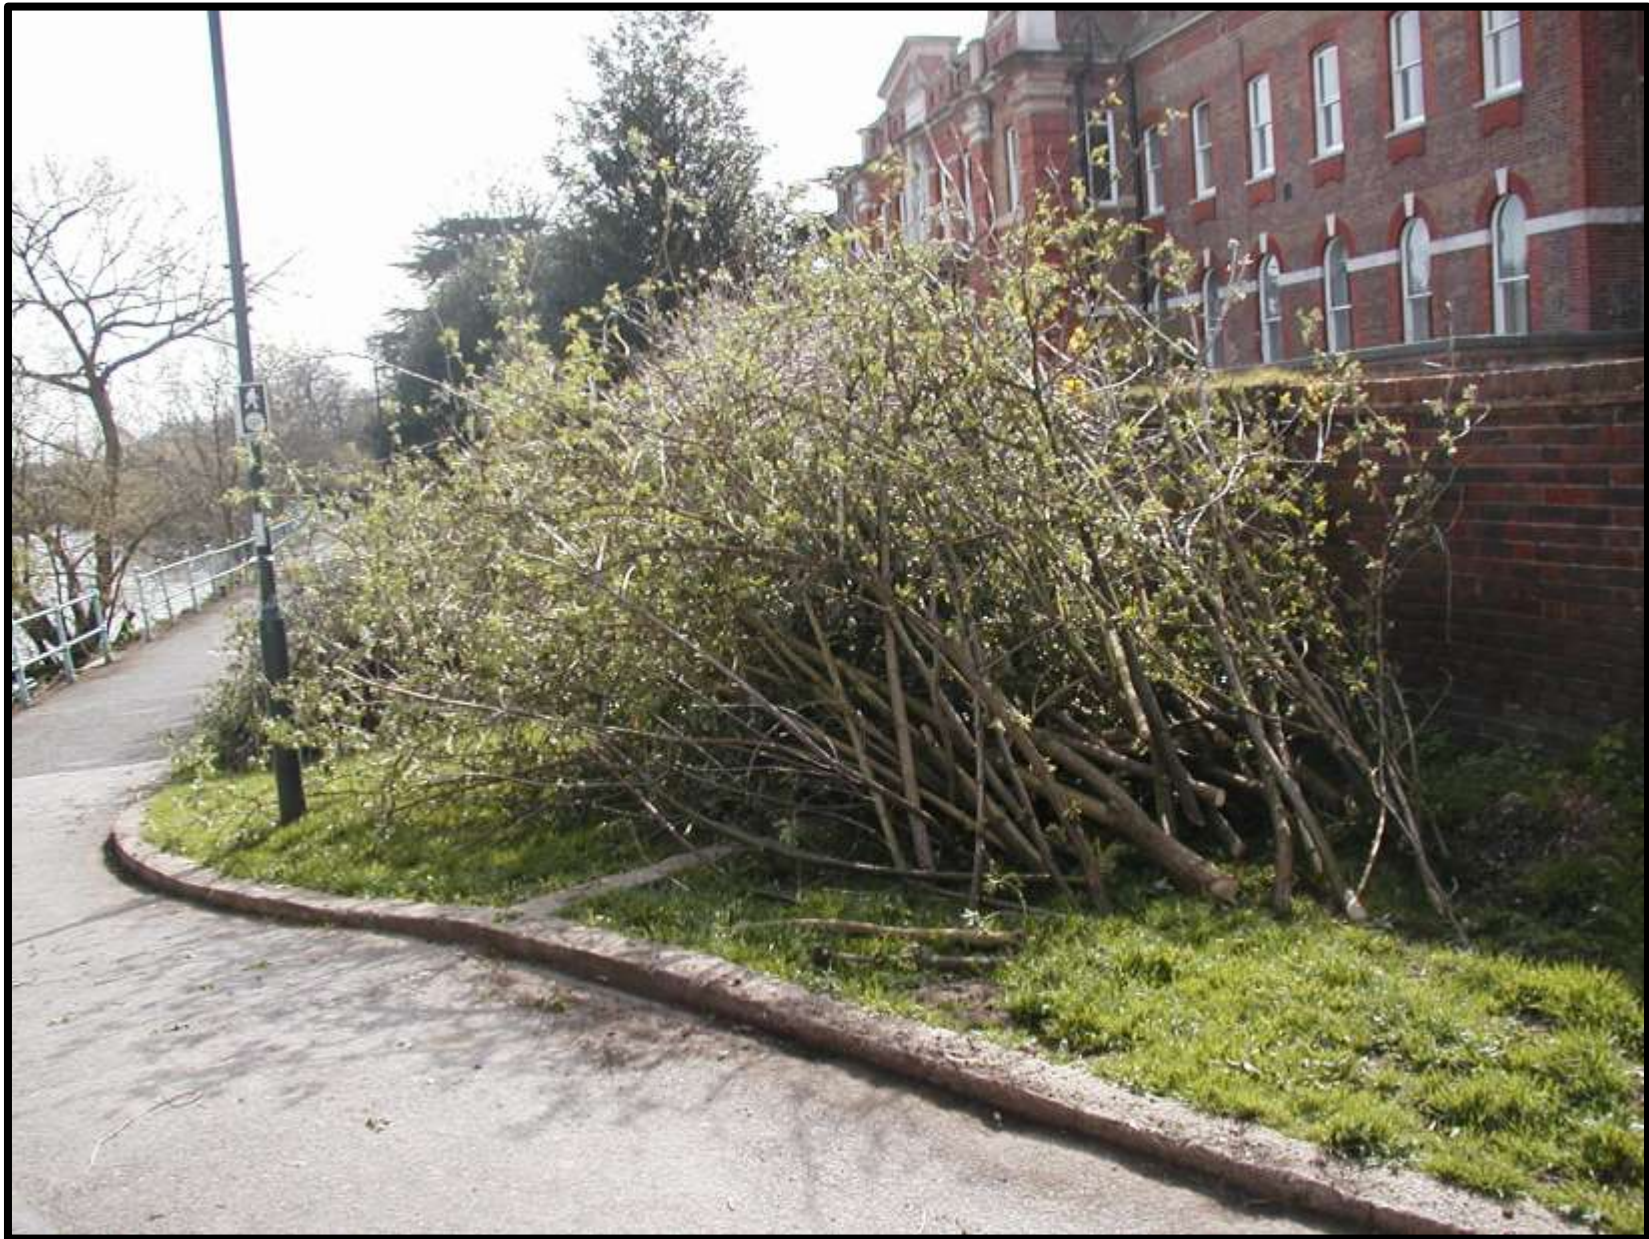
Photo showing cuttings awaiting clearing in front of Gordon House (grade II*) March 2005

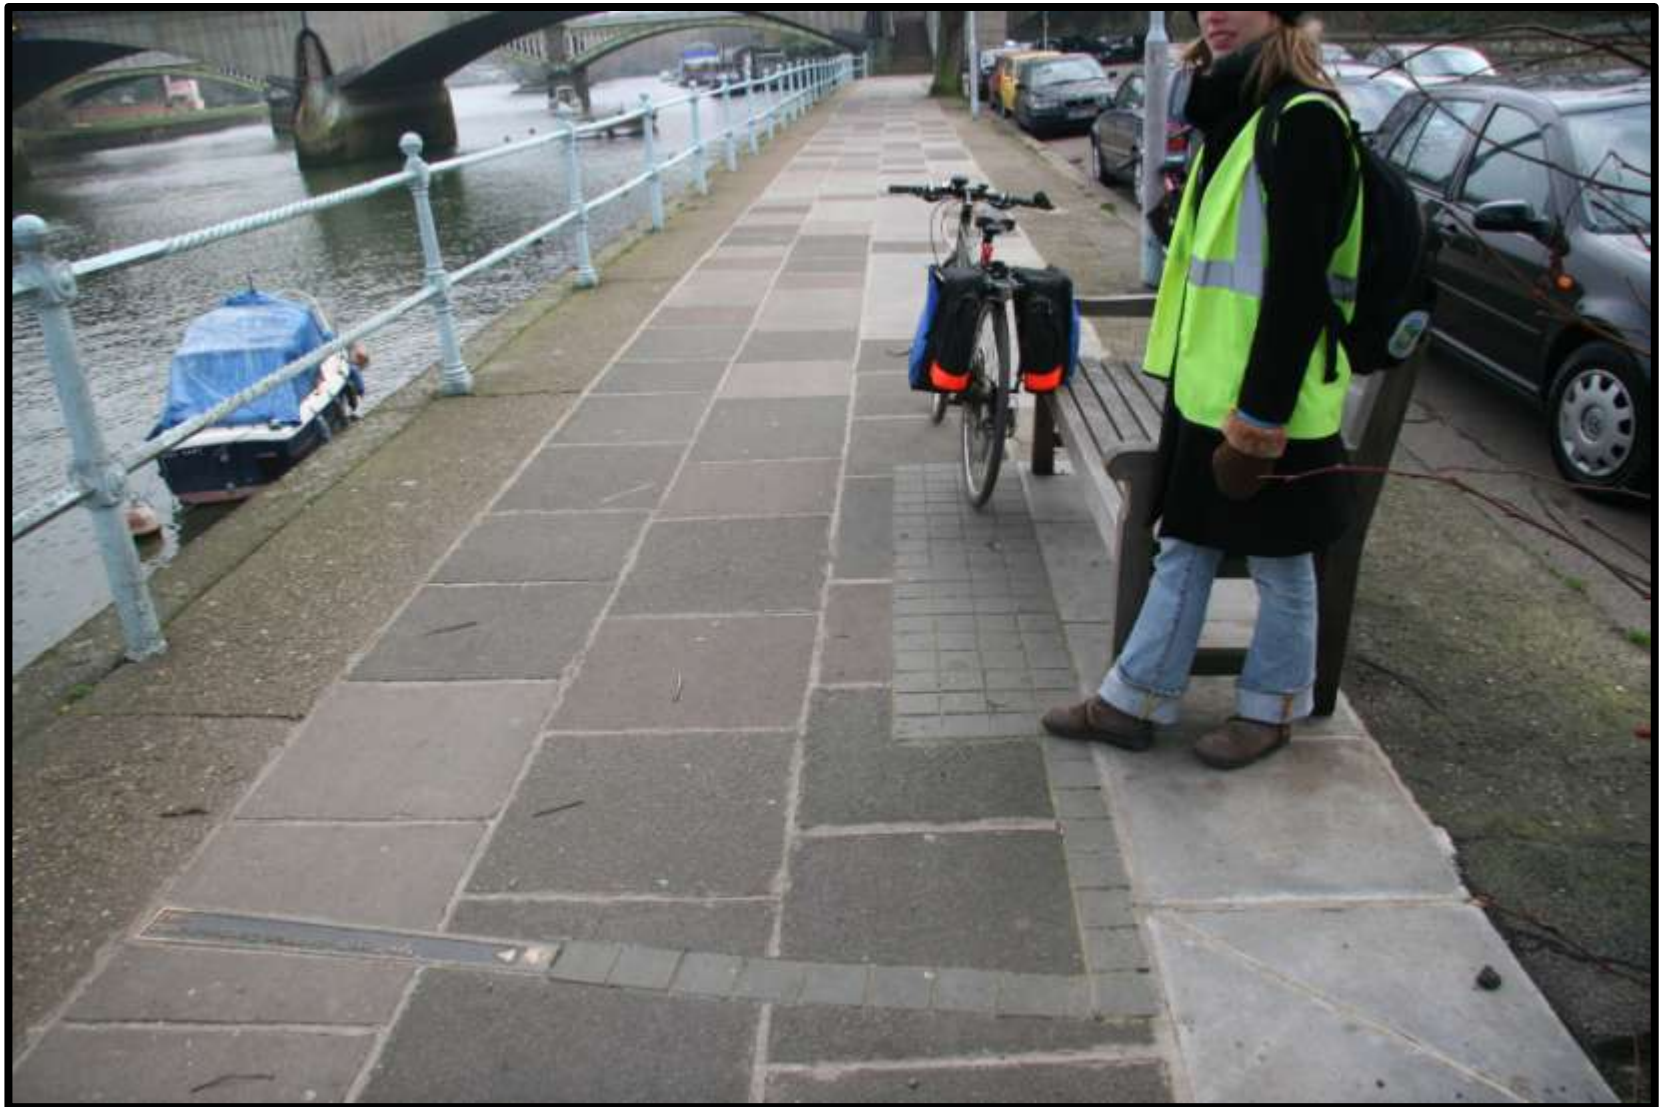
Photo showing Kew Pagoda (grade I) viewpoint interpretation across River Thames and the Old Deer Park (grade I) Feb 2008 along St Margaret's Riverfront- note the restored railings looking upriver to Richmond Railway Bridge
